Manhole Inspection Summary

Manhole # S47G__036MH

Insp Date: **7/30/08 9:32 AM**

Location Address: **204 S Patterson Ave**

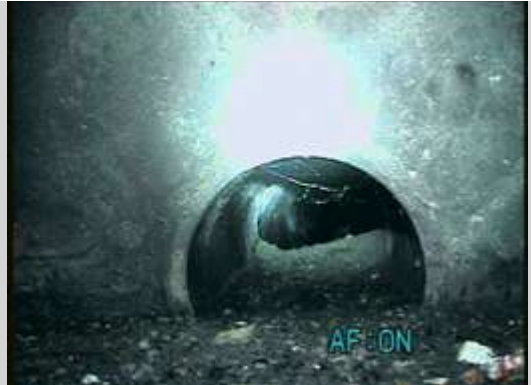
12 O'Clock Outflow

8 in. Circular Gravity Sewer
Pipe Out @ 12 O'Clock

Pipe Material: **Clay** ☐ Pipe Lined

Infiltration: **None** Pipe Seal Cond: **Unknown**
